Silver Lake Improvement Feasibility Study and 5-Year Management Plan Oceana County, Michigan

**Provided for: Silver Lake Improvement Board
Pursuant to P.A. 451 of 1994 as amended**

**Dr. Jennifer L. Jermalowicz-Jones, Water Resources Director
18406 West Spring Lake Road
Spring Lake, Michigan 49456
info@restorativelakesciences.com
www.restorativelakesciences.com**

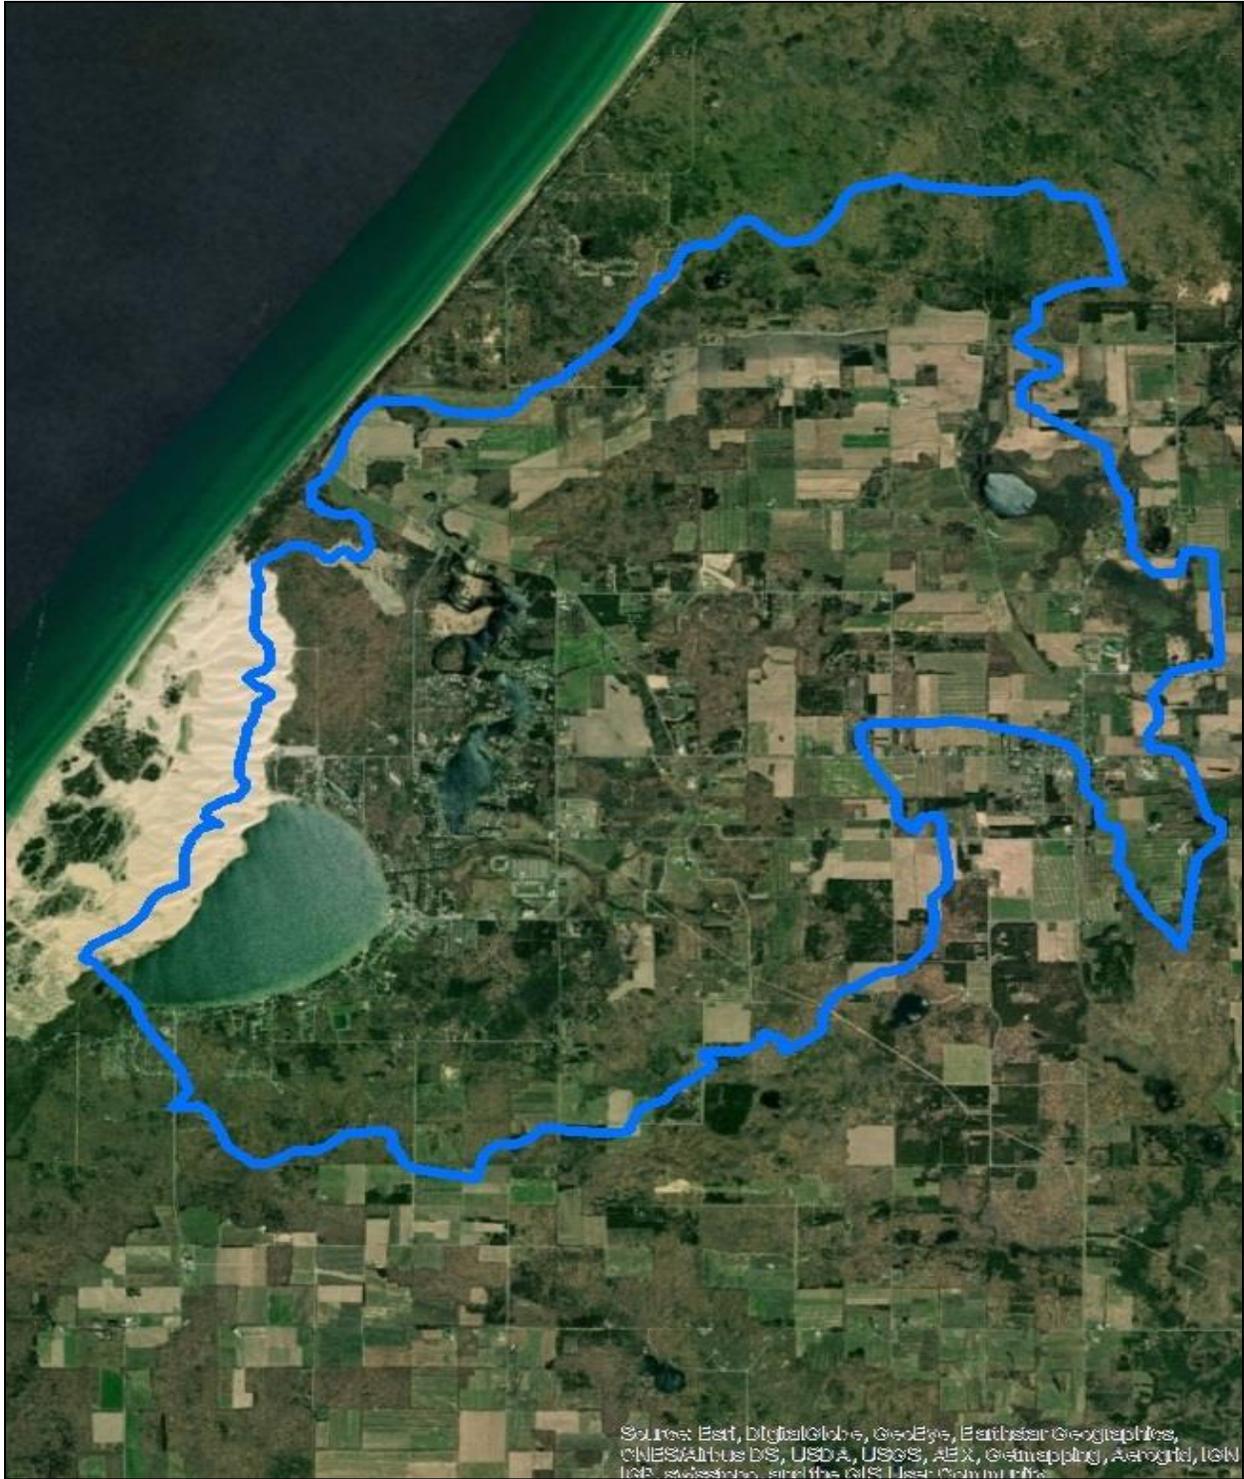
Silver Lake's immediate watershed consists of the area around the lake which directly drains to the lake and measures approximately 12,384 acres (19.4 mi²) in size (Figure 4; RLS, July 23, 2018).

Figure 4. Silver Lake immediate watershed boundary (RLS, July 23, 2018).

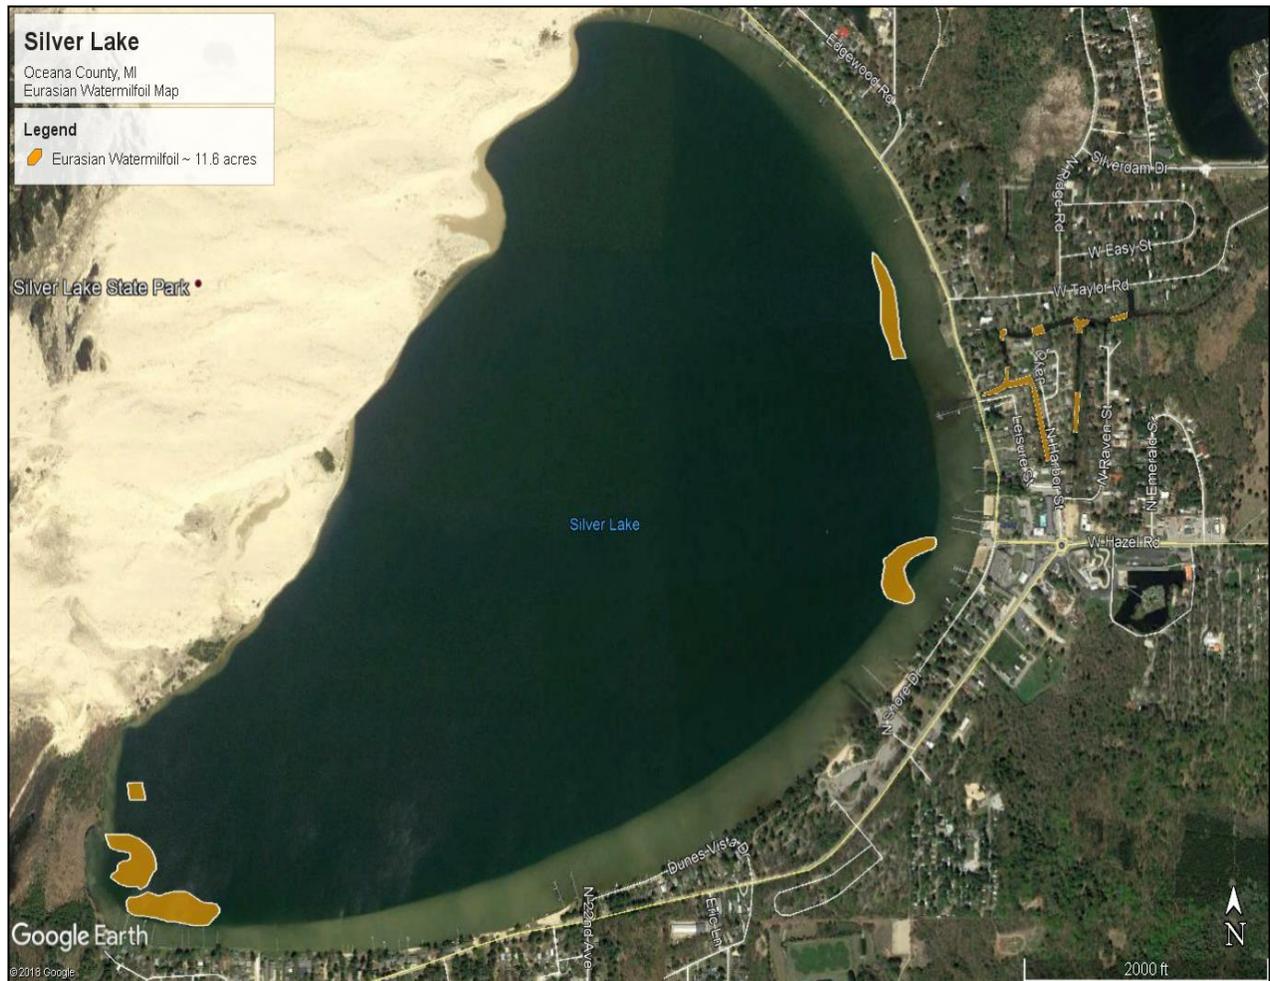
Figure 10 shows the general distribution of the hybrid Eurasian Watermilfoil in Silver Lake on July 23, 2018. Table 6 below shows all exotic aquatic plant species in Silver Lake and the canals such as Hunter Creek as of July 23, 2018.

Figure 10. Distribution of Hybrid Eurasian Watermilfoil in Silver Lake, Oceana County, MI. (July 23, 2018).

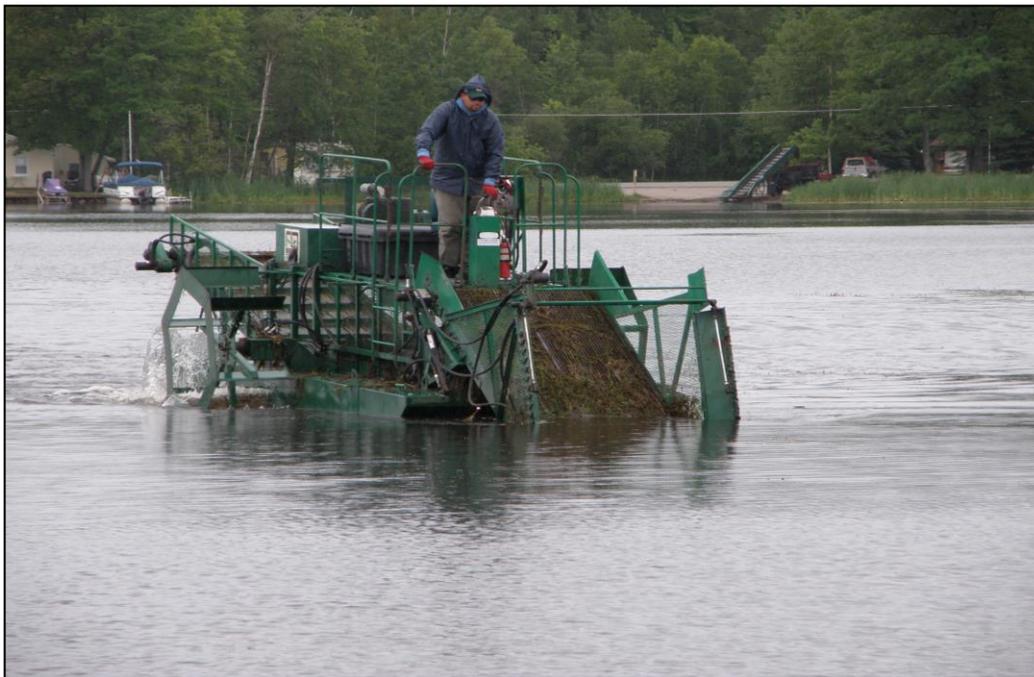
Mechanical harvesting involves the physical removal of nuisance aquatic vegetation with the use of a mechanical harvesting machine (Figure 20). The mechanical harvester collects numerous loads of aquatic plants as they are cut near the lake bottom. The plants are off-loaded onto a conveyor and then into a dump truck. Harvested plants are then taken to an offsite landfill or farm where they can be used as fertilizer. Mechanical harvesting is preferred over chemical herbicides when primarily native aquatic plants exist, or when excessive amounts of plant biomass need to be removed. Mechanical harvesting is usually not recommended for the removal of Eurasian Watermilfoil since the plants may fragment when cut and re-grow on the lake bottom. Due to the fact that milfoil is present in Silver Lake and fragmentation is a threat, mechanical removal is not recommended at this time.

Figure 20. A mechanical harvester.

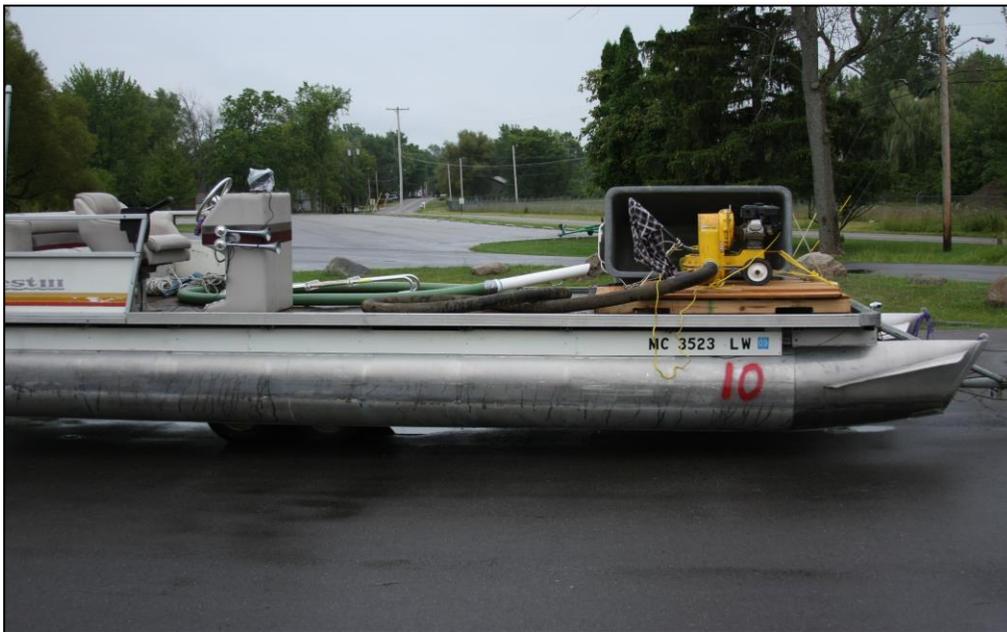
Suction harvesting via a Diver Assisted Suction Harvesting (DASH) boat (Figure 21) involves hand removal of individual plants by a SCUBA diver in selected areas of lake bottom with the use of a hand-operated suction hose. Samples are dewatered on land or removed via fabric bags to an offsite location. This method is generally recommended for small (less than 1 acre) spot removal of vegetation since it is costly on a large scale (costs range from \$1,000-\$5,000 per acre). It may be used in the future to remove small remaining areas of milfoil if a non-chemical method is then preferred. If the DASH method is used on aquatic plants that fragment, then the use of a barrier to prevent movement of the fragments is recommended. Furthermore, this activity may cause re-suspension of sediments (Nayar et al., 2007) which may lead to increased turbidity and reduced clarity of the water. This is especially the case when this method is conducted in soft, flocculent sediments. The process requires a permit from the MDEQ and U.S. Army Corps of Engineers.

Figure 21. A DASH boat for hand-removal of milfoil or other nuisance vegetation. ©RLS

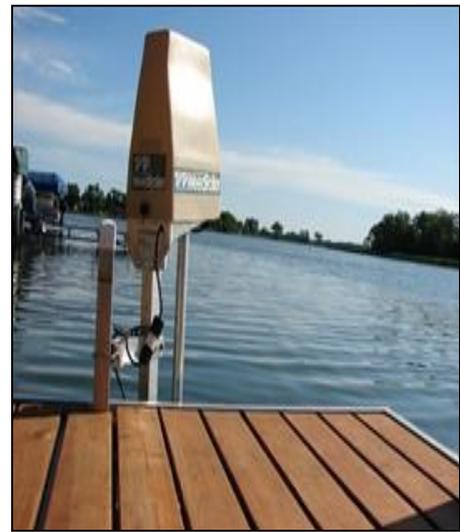
Weed Rollers are electrical devices which utilize a rolling arm that rolls along the lake bottom in small areas (usually not more than 50 feet) and pulverizes the lake bottom to reduce germination of any aquatic vegetation in that area. They can be purchased online at: www.crary.com/marine or at: www.lakegroomer.net.

Figure 23. A Weed Roller

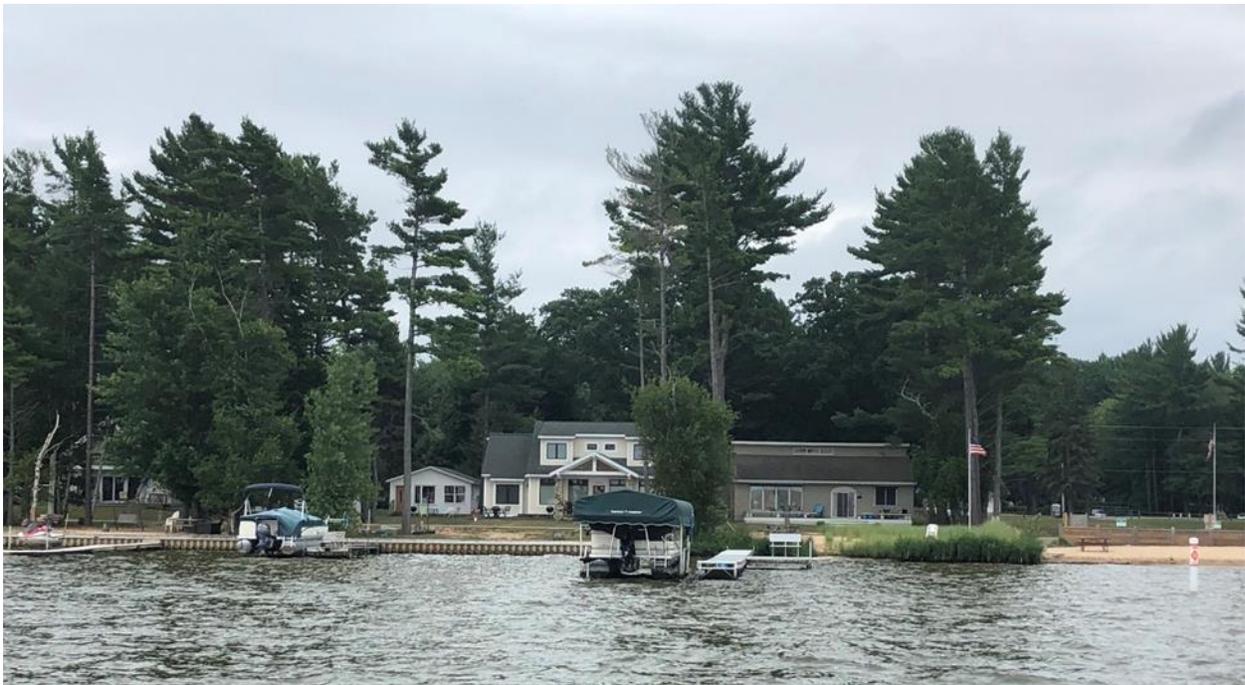
Figure 26. Area to the left is an example of seawall with no vegetation present. To the right is an example of a well vegetated shoreline.

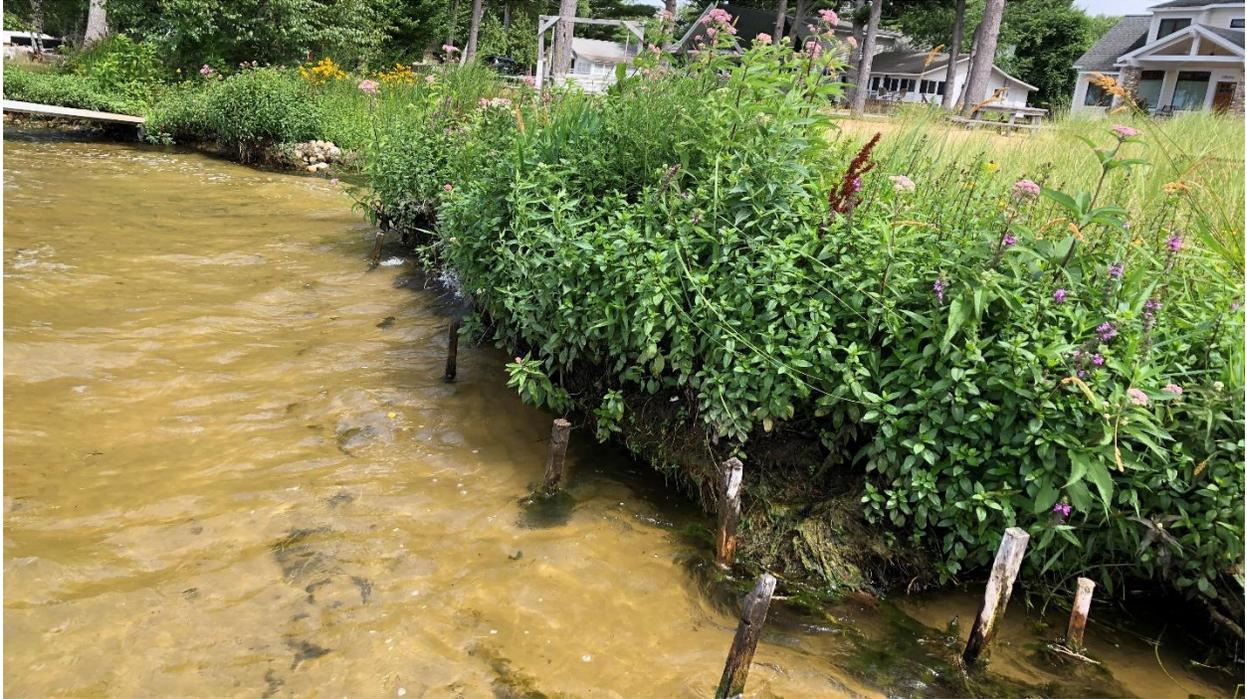
Figure 27. Up-close picture of the area in figure 1. This has been planted with native herbaceous vegetation.

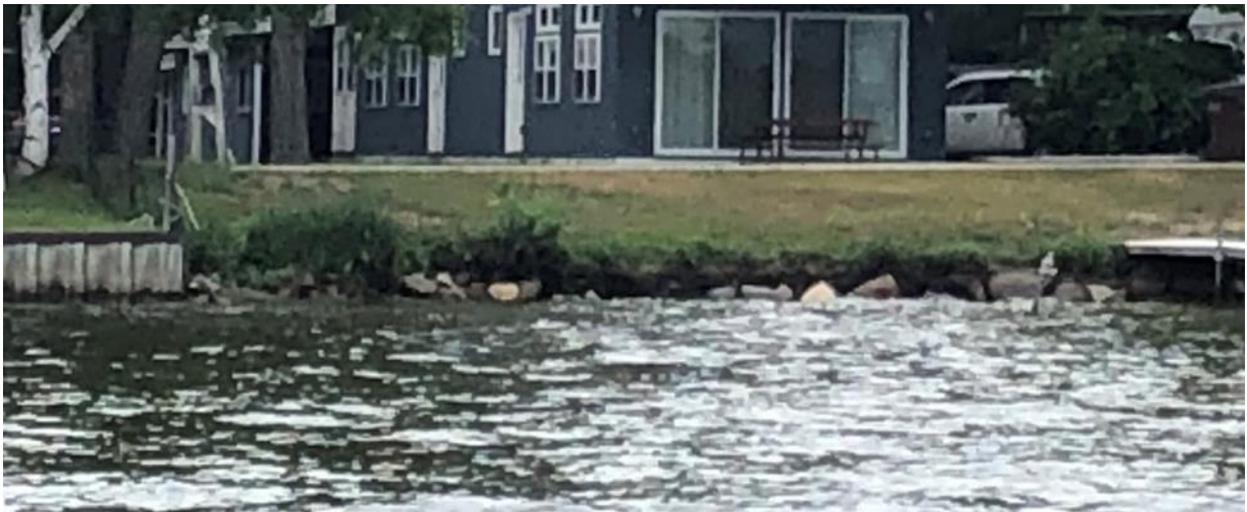
Figure 28. Rip-rap failure due to wave action and high-water levels.

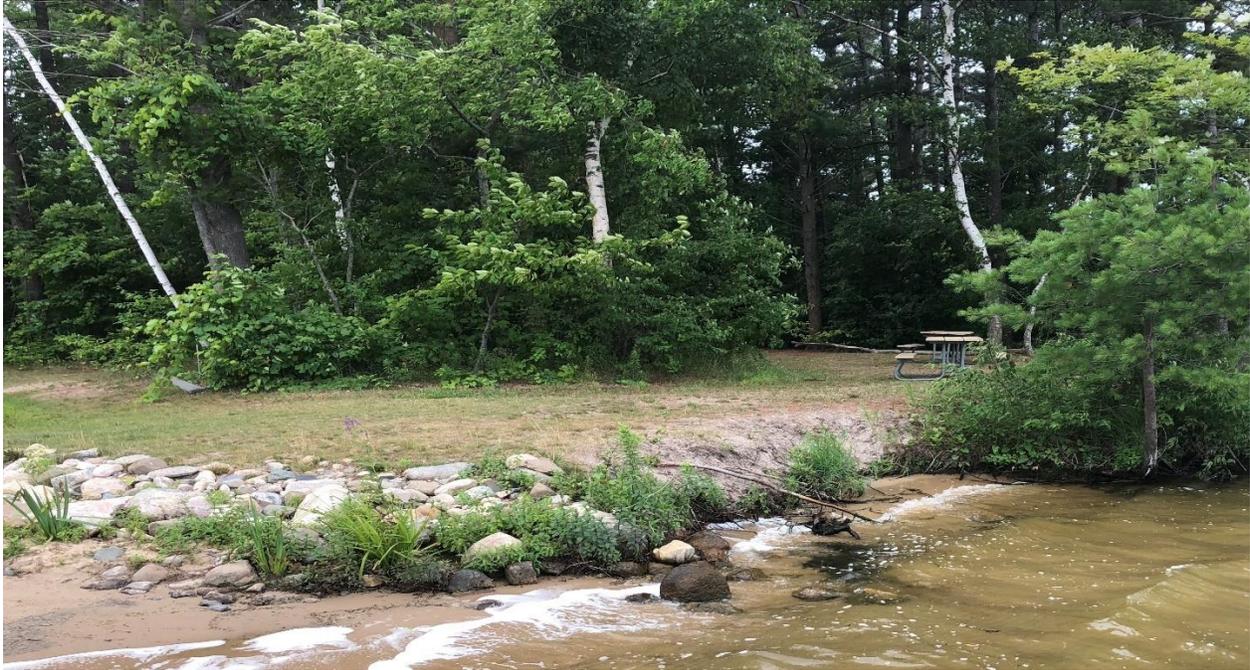
Figure 29. Erosion site located at state park campground is an ideal candidate for natural shoreline restoration.

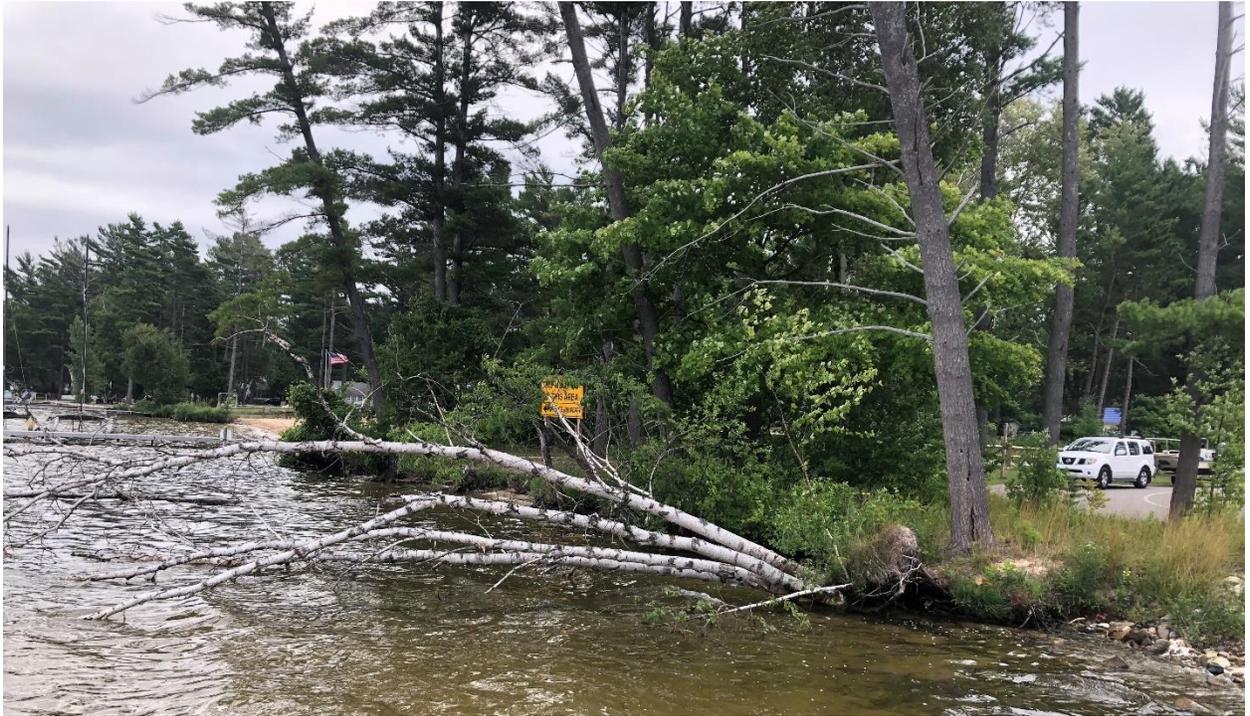
Figure 30. Erosion site located at state park boat launch is an ideal candidate for natural shoreline restoration.

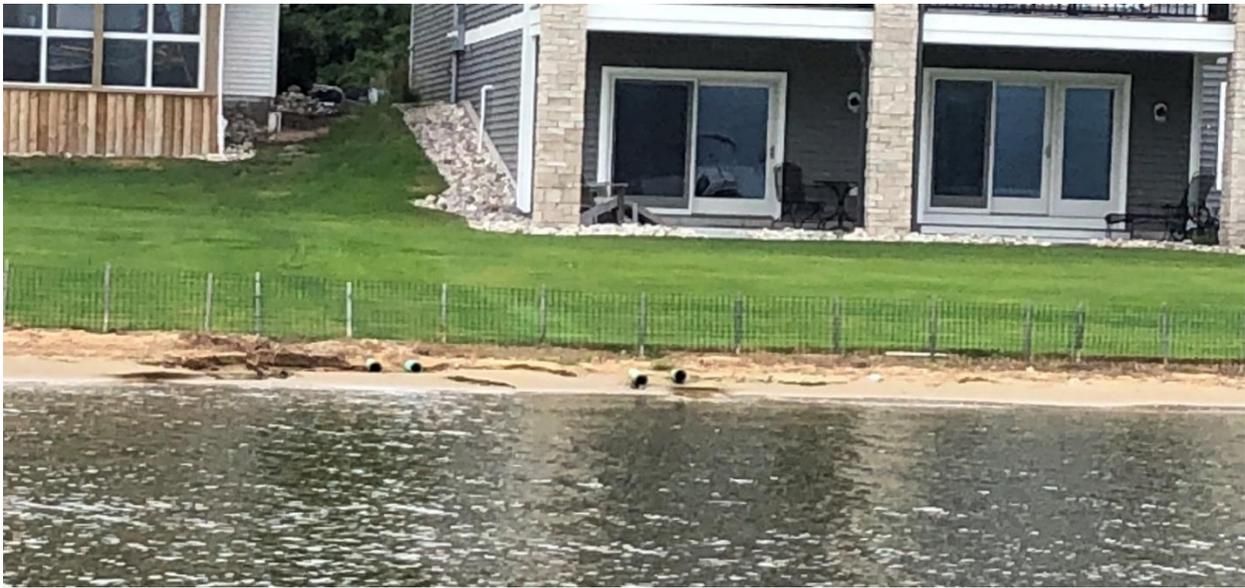
The northern shoreline is semi-protected by its cove-like geometry, sandy group A soils, and low sloping landscape. This area is dominated by manicured lawns (Figure 31 and 32), with small sections of natural vegetation present (Figure 33). There is minimal shoreline degradation occurring in this area except for drainage pipes causing some minor beach gully erosion (Figures 34 and 35). The establishment of emergent shoreline vegetation in these areas will slow the rate of beach loss, filter nutrients and provide aquatic habitat.

Figure 31. Example of manicured lawn in place of natural shoreline vegetation. Drainage discharge causing beach erosion.

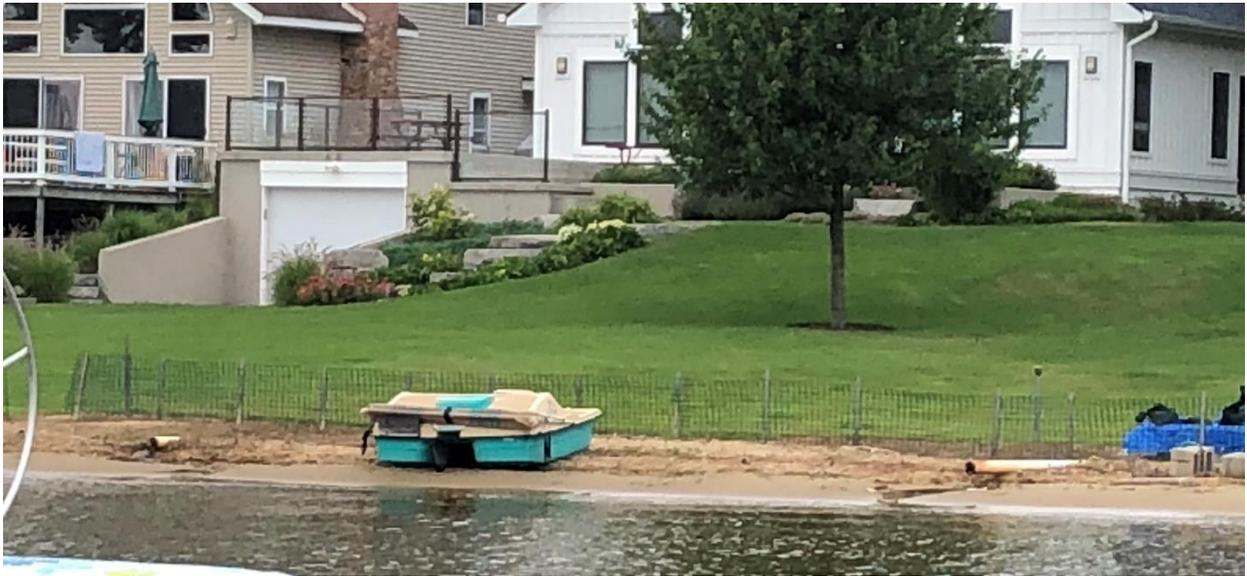
Figure 32. Example of manicured lawn in place of natural shoreline vegetation. Drainage discharge causing beach erosion.

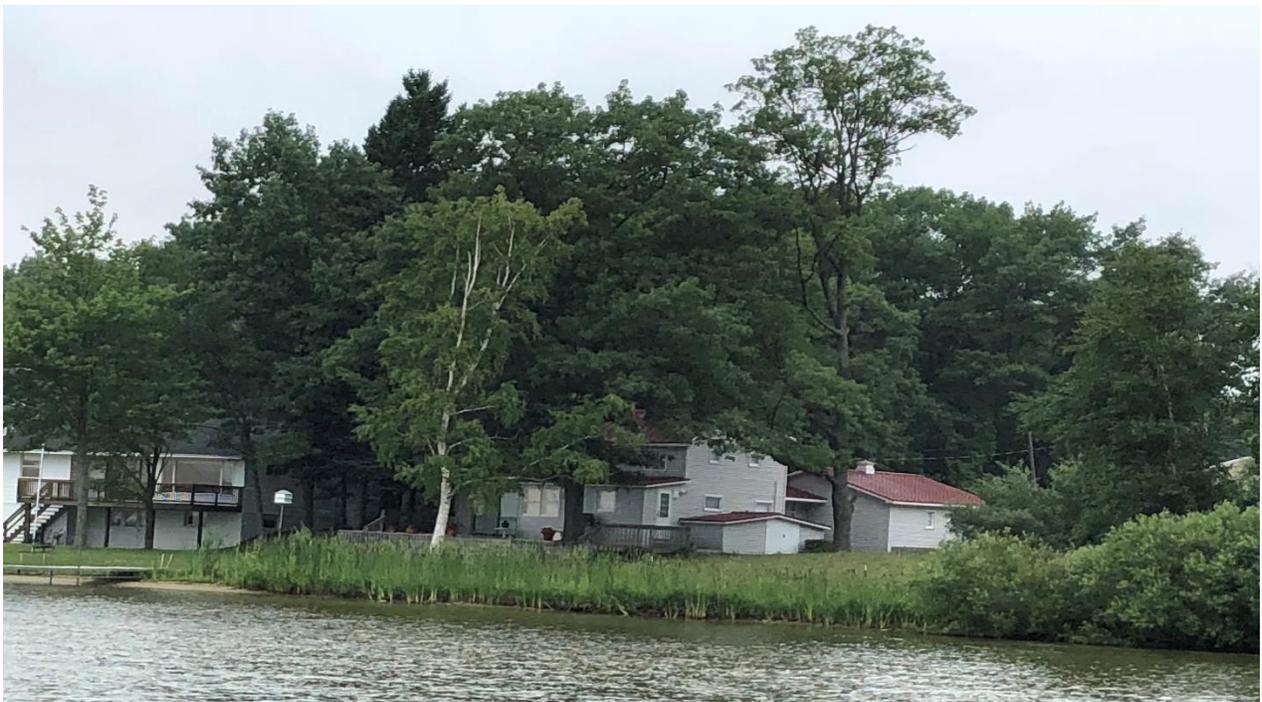
Figure 33. Example of naturally vegetated northern shoreline with no signs of active erosion.

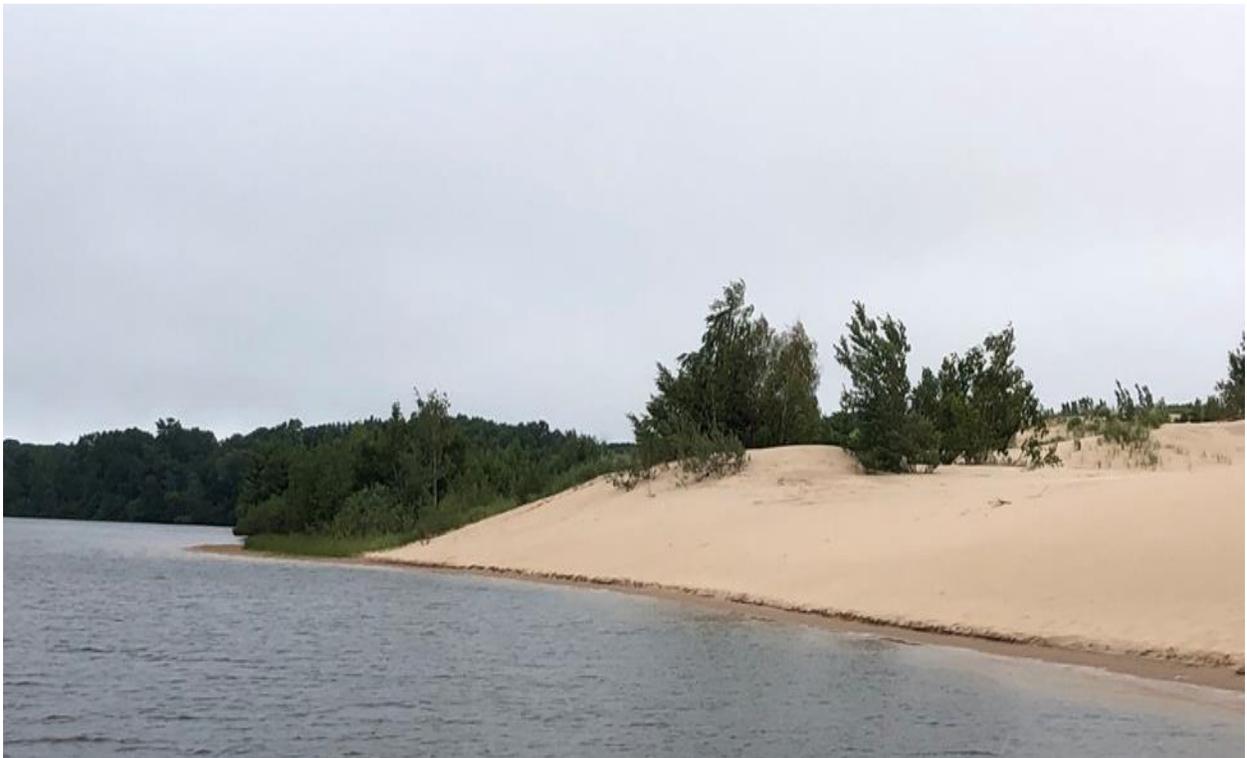
The western shoreline consists of shifting sand dunes (Figure 34) and some emergent shoreline vegetation in other areas (Figure 35). While there are high slopes and sand particles are free to move due to the lack of vegetation, they often do not become suspended in the water column and thus not a threat to water quality. RLS does not recommend any shoreline erosion controls in this area.

Figure 34. Western shoreline with sand dune area. No signs of active erosion were identified.

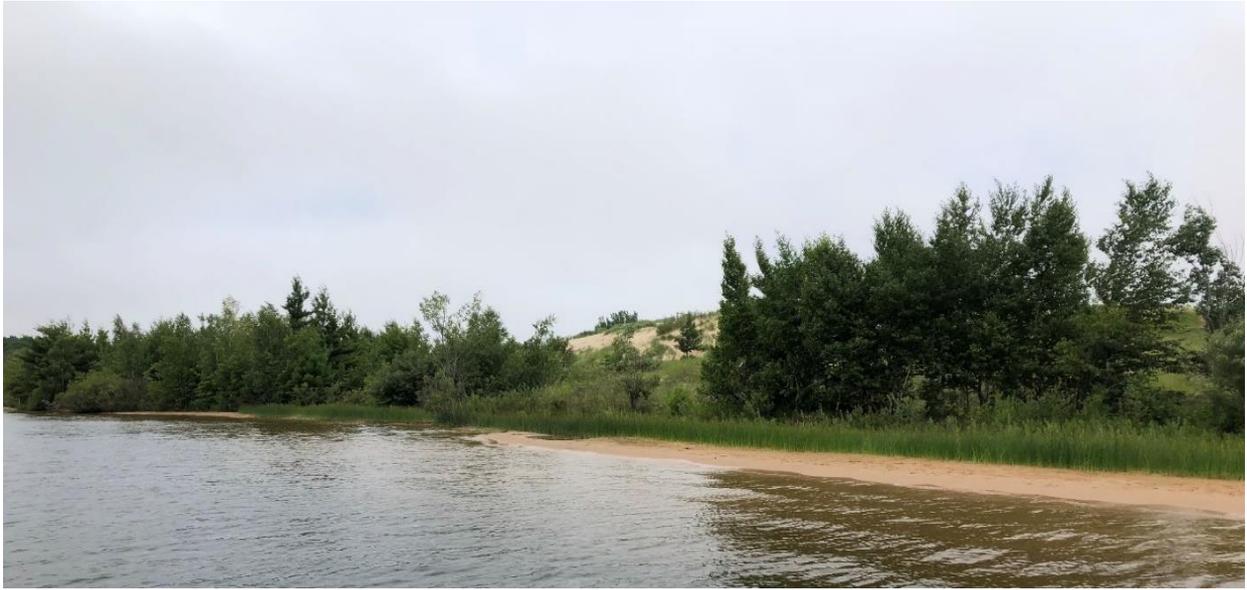
Figure 35. Western shoreline with emergent wetland vegetation and no active erosion.

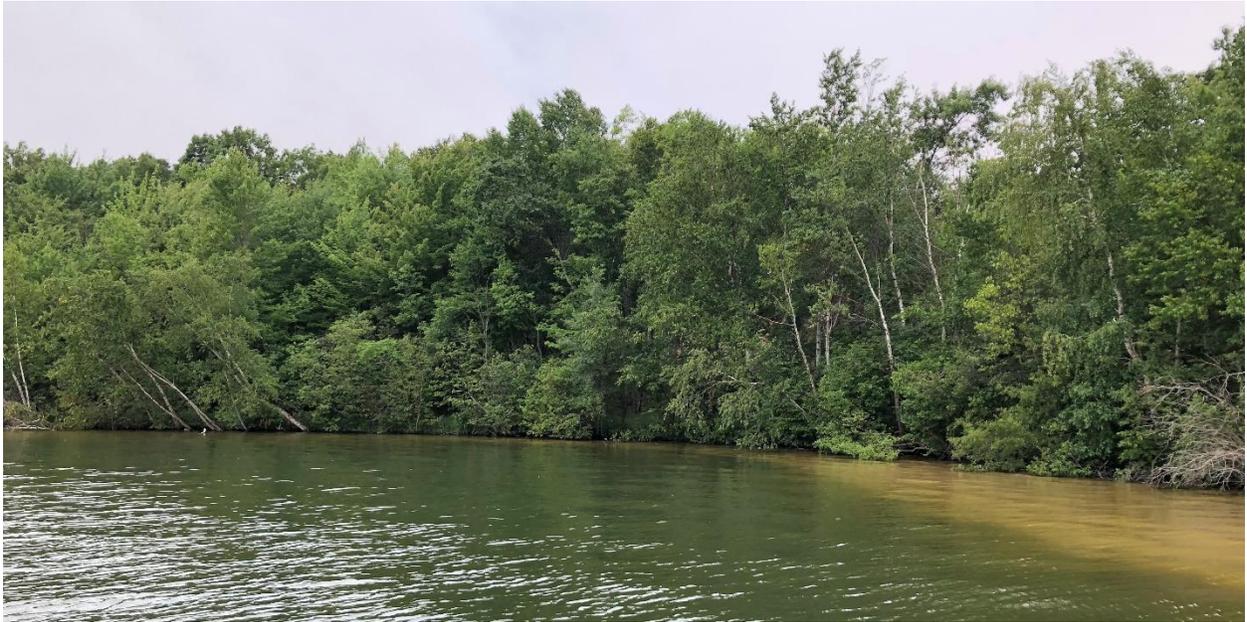
Silver Lake's southern shoreline is undeveloped with a vigorous, naturally vegetated landscape (Figure 36). This is a great example of an ideal shoreline that includes a favorable swath of emergent aquatic vegetation at the nearshore shallows, such as hard-stem bulrush, backed by wetland species, such as herbaceous plants, shrubs and trees including swamp loosestrife, willow, buttonbush, and other larger tree species (Figure 37). This location is also semi-protected from prevailing westerly winds. No areas of concern with active erosion were found here. This location is part of the Silver Lake State Park and consists of wetlands and bogs, thus likely to be preserved in its current state.

Figure 36. Example of an undisturbed, natural shoreline at the southern end of the lake.

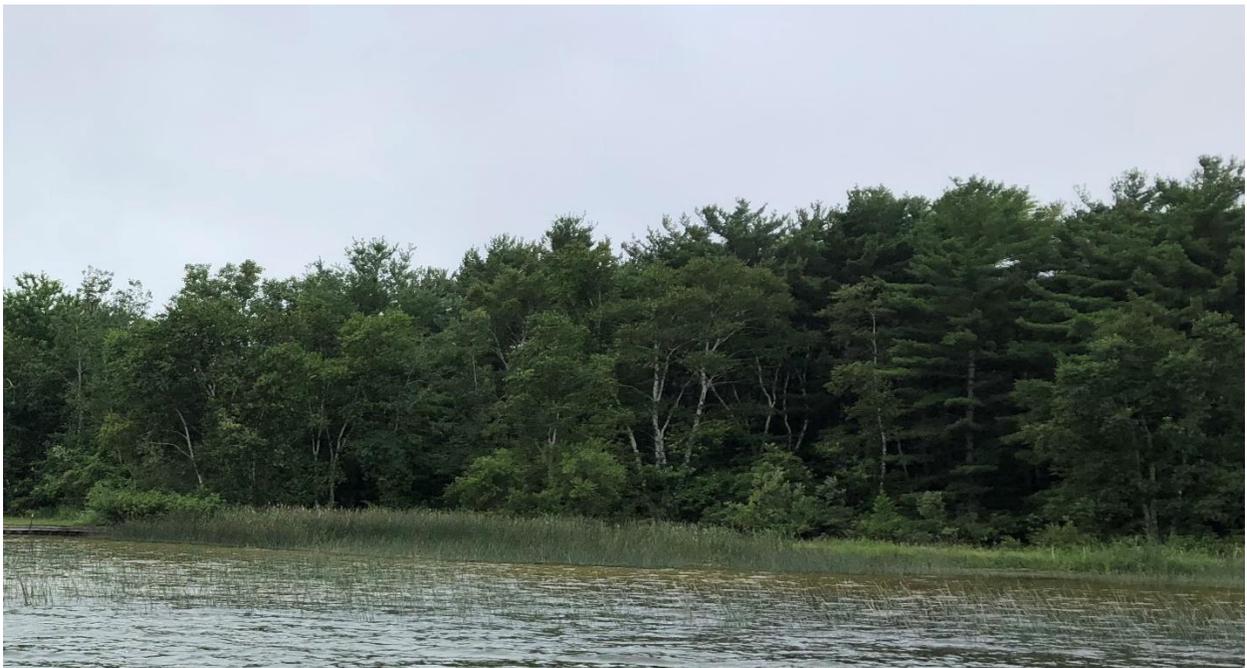
Figure 37. Example of an undisturbed, natural shoreline at the southern end of the lake with shallow water emergent bulrush.
